ABSTRACT

Michael R Horne, National Institute of Aerospace, 100 Exploration Way, Hampton VA 23666-6147, U.S.A..

Peter D Juarez, NASA Langley Research Center, Hampton VA 23681, U.S.A.

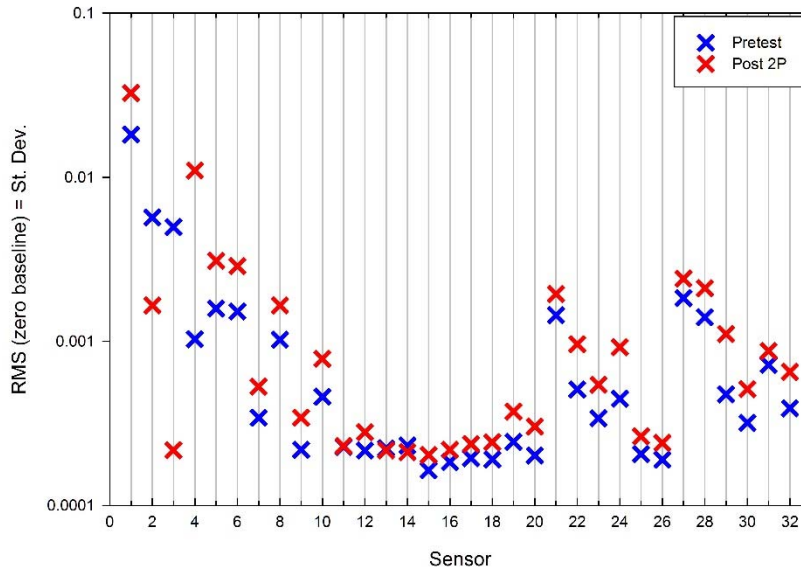
Figure 4 RMS values of signals received at all sensors from PLB at sensor 1

Indications of damage were discovered when two series of PLBs were executed: one prior to pressurization (“pre-test”) and one after the applied impact (“post-2P”) but before the final failure test. The PLBs were conducted approximately an inch away from each sensor in the same consistent manner as noted in the standard and signals collected from all sensors (see discussion in [5]).

For these PLB tests, an indication of the energy collected at each sensor was made by calculating the RMS (root-mean-square) value for each collected waveform. For example, Figure 4 shows, for a PLB at sensor 1, two of the post-2P values are lower than the pre-test values. This reduction is the expected response of distributed damage, all other things being equal. Figure 4 also illustrates the opposite behavior where many of the post-2P (and post-impact) RMS values are larger than the pre-test values. Since

these sensors, as noted previously, are only sensitive to surface displacement, they are not measuring the entire flux of energy flow in the plate. Early distributed damage, if significantly smaller than a wavelength, should tend to attenuate wave propagation. However, with later damage localization and growth, such as delamination, wave propagation encountering these damage structures would be subject to reflection, refraction and diffraction. It is plausible that these behaviors could result in increased energy measured at the surface. In fact, simulations by Leckey and Seebo [7], Sohn et al [8], and Tian, et al [9] show increased out-of-plane cumulative energy in the area of a delamination for waves propagating along a plate. For these tests, it is suggested that in a damaged state prior to formation of a complete delamination, the existing damage (for example network of matrix cracking) could also begin to induce increased energy measured at the surface. Since the sensors were co-located with stringers (potential damage initiators), it is plausible that these results reflect damage creation in those regions.

Therefore, a comparison was executed to count the number of times a sensor received greater signal RMS during the post 2P series. The sensor cables were disconnected for the impact procedure and the PLBs were not performed in exactly the same location for each series. To account for these effects a parametric study was executed where the differences in signal amplitude had to be greater than a threshold level to count as being different. Varying the threshold over a reasonable range and tabulating the results by panel it was shown that; in general, the count was proportional to the extent of the damage accumulation in the panel. The rib panel that initiated failure and the bulkhead panel that blew off had the highest counts. The crown that had delamination early on was typically third and the other two panels had the lowest counts.

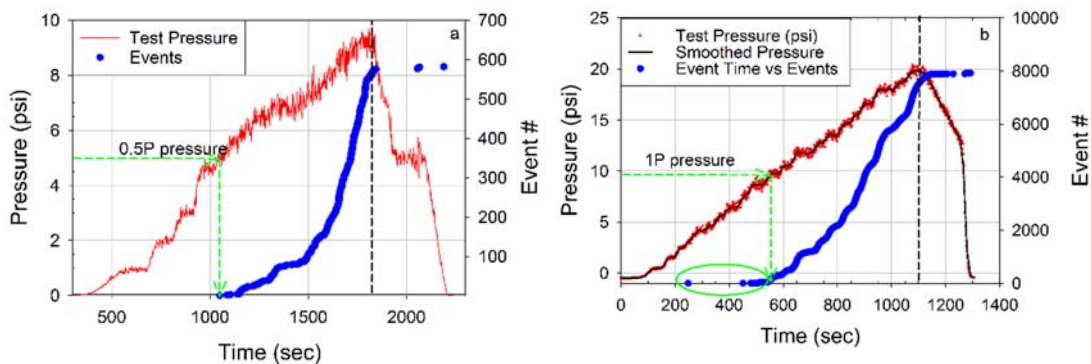
Figure 5. Event plots for Pressure cube tests a) 1P b) 2P (P = 9.2 psi)

Damage initiation can also be indicated by the timing of AE events relative to the peak load and the previous peak load (see Kaiser Effect [10]). In the plot of pressure and AE events vs. test time for the 1P test seen in Figure 5a, the peak pressure of the previous 0.5P test is denoted by the green dotted line. No AE is occurring prior to this level of pressure, indicating that the 0.5P test did not create any significant damage. However, there are some events occurring during unloading (region to the right of the black dotted line). AE events during unloading typically occur from internal friction of damage surfaces indicating creation of some significant damage during the 1P test. In the plot of pressure and events vs. time for the 2P test seen in Figure 5b, the indication that some significant damage was created during the 1P test is supported further by the AE occurring before the 2P test reaches the 1P pressure level (indicated by the green oval). The larger amount of AE during unloading in the 2P test (relative to the 1P test) indicates even greater extent of damage created during the 2P test. The failure test, not shown here, has an even greater number of AE events prior to reaching the 2P load level than the noted number of events prior to reaching 1P in the 2P test. This indicates an increasing rate of damage development. The Felicity Ratios, which are calculated from the timing of AE events as noted above, [10] for the 1P, 2P, and failure tests are approximately 1.00, 0.76, and 0.65 respectively. The Pressure Cube was a pressure vessel, but the construction is significantly different from a composite overwrapped pressure vessel, so, the failure modes are different. However, for a point of reference, a Felicity Ratio less than 0.95 is a criterion for rejecting composite overwrap pressure vessels during proof testing [11, 12]. Point being, the decreasing Felicity ratio is another indication of the increasing damage development.

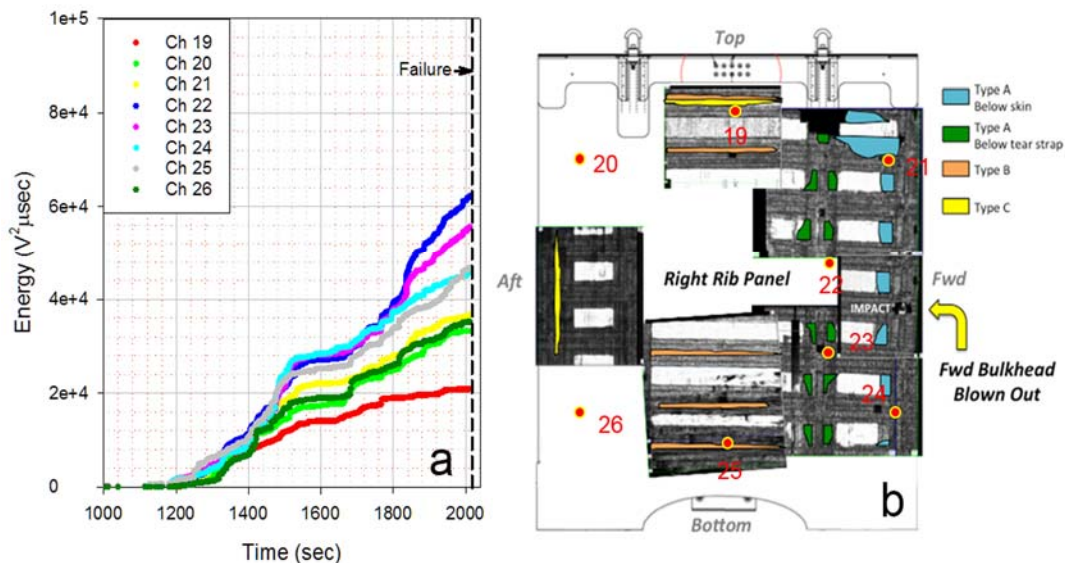
Figure 6. Post-mortem of pressure box impact rib panel. a) AE Cumulative energy for the Failure test. b) Ultrasonic C-scan for the same panel after Failure test.

To help quantify the meaning of “damage development” the following is a comparison of ultrasonic C-scans and their association with AE that is illustrated in Figure 6. The scans, as seen in Figure 6b, are superimposed over a schematic of the rib

panel. They are post-mortem scans of the impacted rib panel that initiated the blowout of the contiguous bulkhead panel. The cumulative AE energy, presented in Figure 6a, is of the sensors on the impacted rib panel, during the failure test. The sensor locations are indicated in Figure 6b as the numbered red filled circles.

The C-scans show different types of delaminations [13] denoted by the areas of blue, green, orange and yellow. Frames, stringers and integral caps are indicated by the dark gray stripes. Stringers are horizontal. Frames are vertical at the $\frac{1}{4}$ and $\frac{3}{4}$ points widthwise. Integral caps (t-caps) are at the right and left edges of the panel to hold the bulkhead panels. The large majority of delamination acreage is on the right hand side of the panel around the impact and AE sensors 21-25. The right hand edge was the corner of this cube contiguous with the panel that blew out. The right side also contained the metallic frame splice failure at the top near the large blue regions, buckling of the vertical frame under the green delamination acreage, and integral cap failure under the blue acreage. Correlating well with this damage, and indicated in 6a, the sensors with the highest cumulative energy from approximately 1200 seconds until the failure, are sensors 22-25 which are predominately located on the right edge.

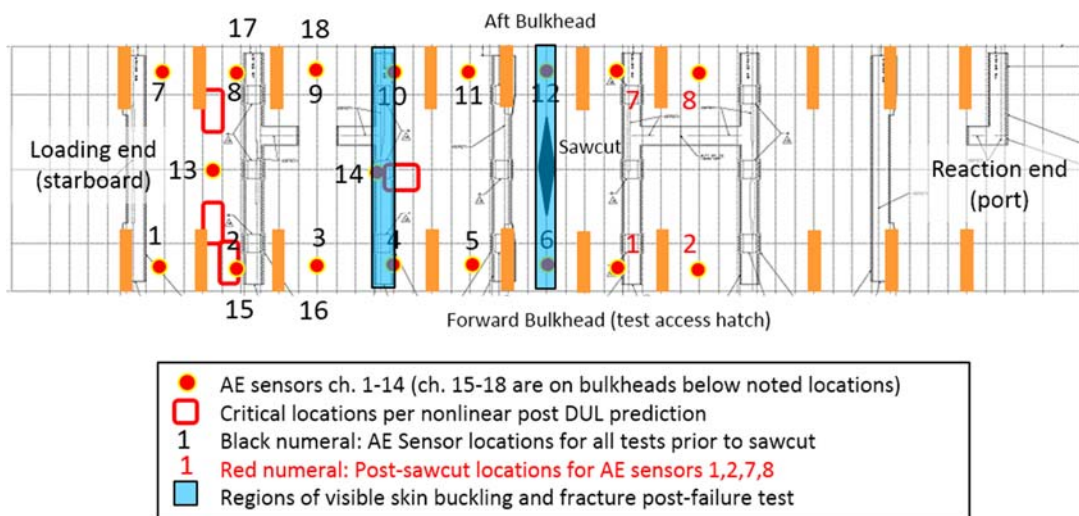
Figure 7. Schematic of MBB crown with AE sensor location, critical areas, and failure regions.

For the final test (denoted as the “post-sawcut failure”) the MBB was loaded by up-bending until failure occurred. The frame in the middle of the crown running parallel to the bulkheads was intentionally completely severed on the midline between port and starboard prior to this test. On the schematic in Figure 7, this is represented by the black

elongated diamond shape between sensors 6 and 12, approximating the shape of the actual sawcut. The fixed or reaction end of the structure is the right hand end of the figure while the loading end is the left. Up-bending denoted in Table 1 is loading out of the paper toward the reader putting the crown predominately in compression lengthwise in the plane of the crown. Down-bending is into the paper, crown is in tension. The location of all the crown AE sensors are indicated by the red filled circles. The red boxes are critical areas identified by a nonlinear prediction of post-DUL behavior[3]. It should be noted that sensors 2, 8, 13, and 14 are located near these critical areas before the post-sawcut test. For the post-sawcut test, sensors 1, 2, 7, and 8 were moved to the reaction (port) side of the saw-cut.

Buckling failure occurred during the last test and extended across the crown in two regions as indicated by the blue strips in Figure 7. The primary buckle extended from the sawcut tips under sensors 6 and 12. The secondary buckle run was under sensors 4, 14, and 10. Extensions of these buckles continued part of the way down the bulkheads. The buckle on the aft bulkhead is a continuation of the secondary buckle extending across sensors 10, 14, and 4. The buckle on the forward bulkhead is the continuation of the primary buckle extending from the sawcut buckle under sensor 6. The offset nature of these indicate some asymmetry in the deformation.

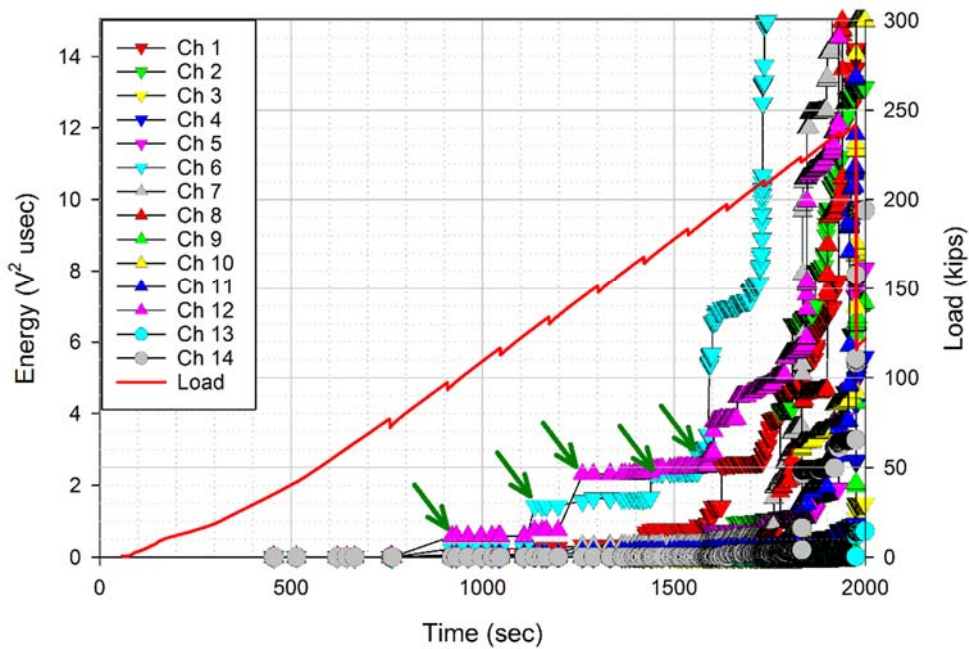
Figure 8. AE Cumulative energy of the MBB crown sensors for the post-sawcut test

The first three trials for the post-sawcut test identified in Table 1 as tests 40-42 were stopped at loads between 2% and 15% of the previous unprecedented up-bending-only test (test 35 in Phase VI post impact DUL) and no AE was generated. The previous unprecedented up-bending-only test had AE starting at only a few percent of peak load. The fact that two of these trials went higher than that level without generating AE indicates the remaining integrity of the structure. It could be suggested that the sawcut

actually reduced local stresses similarly to drilling a hole at a cracktip to stop propagation.

In the final trial, highly localized damage started at tips of the diamond shaped sawcut, near sensors 6 and 12, early in the test, around 900 seconds, as indicated in the plot in Figure 8 of cumulative energy vs time. Between approximately 100 and 200 kips (900 to 1600 sec) is an illustration of load shedding. The damage progression switches back and forth from tip to tip as indicated by the alternating energy jumps at sensors 6 and 12 pointed to by the green arrows. The forward bulkhead tip damage (sensor 6) begins to dominate from approximately 200 kip, possibly reducing stresses along the forward bulkhead-crown edge relative to the aft bulkhead-crown edge. This is another indication of some asymmetry in the deformation.

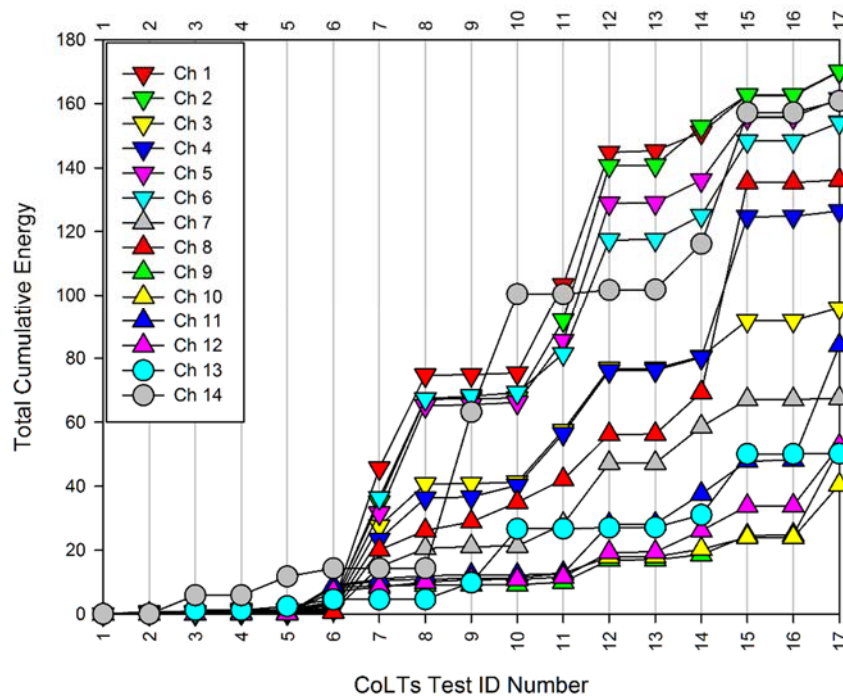
Figure 9. Cumulative AE energy by test for the first seventeen MBB tests.

However, the load shedding from sawcut tips as noted above did not begin in a pristine structure. In fact, the behavior is likely predetermined by earlier testing damage. That can be investigated by looking at plots of the total cumulative energy for all tests in a cumulative manner as seen in Figures 9 and 10. Figure 9 contains the first third of the tests ending with the pre-impact DULs. Figure 10 contains the last third of the tests starting with the post-impact DUL load tests. Intervening tests were repeats of earlier tests so little damage accumulation occurred and consequently very little AE was generated.

Sensors 4, 8, 13 and 14 have distinctly higher increases during test 15, which is up-bending ultimate limit load with pressure. Sensor 4 and sensor 14 are at the forward end and middle, respectively of the future secondary buckle. Sensor 14 is also very near a critical area. It is likely test 15 is the initiation of the weakening contributing to the secondary buckle.

Examining sensor 14 behavior is noteworthy because it is located in a future damage region and in a critical area, and it started to out-increase the others in test 3 (the very first up-bending-only test). It then quickly increased during tests 9 (the next up-bending-only test) and 10 (up-bending + pressure) and eventually moved to near the top of the energy range. Sensor 13, which may be near two critical regions (but not as close as 14 is to its nearest critical area), does not show much increase for the rest of tests and ultimately that region does not appear to have contributed to any failure damage.

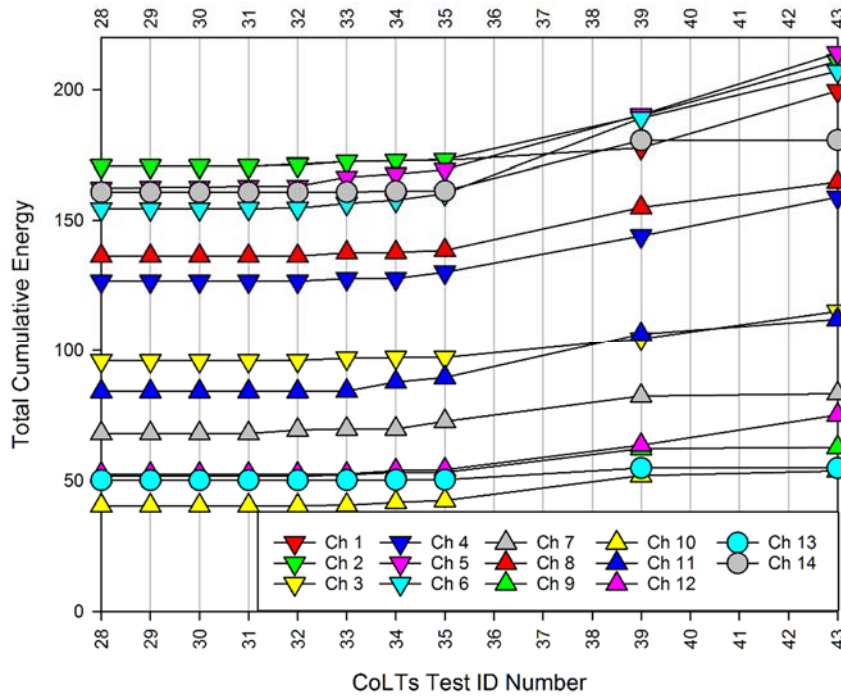
Figure 10. Cumulative AE energy by test for the last sixteen MBB tests.

Starting at the end by looking at Figure 10 there is no obvious indication of when any critical damage occurred near sensors 6 and 12. In fact, sensor 6 is near the top of the range of cumulative energy, sensor 12 is near the bottom, and very little accumulation occurs for most of the tests. Also it should be noted that most of the forward edge sensors (1-6, indicated by down pointing triangle) are in the upper half of

the energy range while the most of the aft (7-12, indicated by up pointing triangle) are in the lower half. This indicates that the forward edge accumulated more damage. This also supports the concept of load shedding toward the aft side, contributing to the first large increase in sensor 12 in the post-sawcut test. The earlier tests in Figure 9 show significant increases in energy at sensor 6 over sensor 12 during test 7 (first down-bending design limit load), then again in test 8 (down-bending design limit load + pressure). Not much occurs during the subsequent up-bending design limit load tests. This pattern repeats for sensor 6 (and many others) during the ultimate limit load tests: significant increases for the down-bending tests 11 and 12, but not much for the subsequent successful up-bending tests 14 and 15. Test 13, although up-bending, does not exhibit the behavior because it was a trial test that did not reach target loads. Sensor 12 is still near the low end.

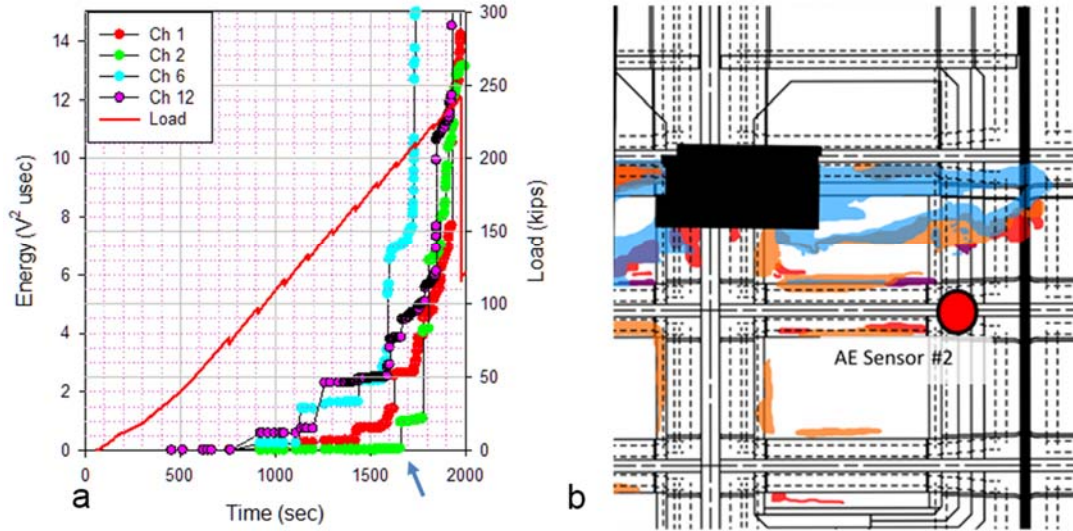
Figure 11. Post-mortem of MBB crown near AE sensor #2. a) AE Cumulative energy for the post-sawcut test. b) Schematic of delaminations discovered by ultrasound after post-sawcut test.

Again, to help quantify the meaning of “damage development” the following is a comparison of ultrasonic C-scans and the AE, illustrated in Figure 11. Seen in Figure 11 is a comparison of the post-mortem schematic of the delaminations found by ultrasonic C-scans of a section of the crown near sensor 2 (11b) and the cumulative energy for the post-sawcut failure test (11a). The different types of delaminations are denoted in 11b by the areas of different colors [14]. The location of AE sensor #2 is denoted as a red dot with black border. The black dashed lines are the stitch lines for the stringers and frames. The solid black lines are denoting changes in geometry such as flange edges, ply drop-offs, or stack faces. In this schematic, the stringers are horizontal at each set of four closely spaced dashed lines. A frame is running vertical on the left side of the schematic under the black region that represents an area that was not scanned. A t-cap runs vertical on the right side of the image under the AE sensor.

Looking at the trace for sensor 2 in 11a there is almost no energy accumulation until approximately 6 minutes before the catastrophic failure. At that time, the first large increase (blue arrow) is likely the beginning of the delamination damage.
